Green Acres

Construction Services, a Tecta America company, installs a vegetative roof system on the Birmingham SSA Center

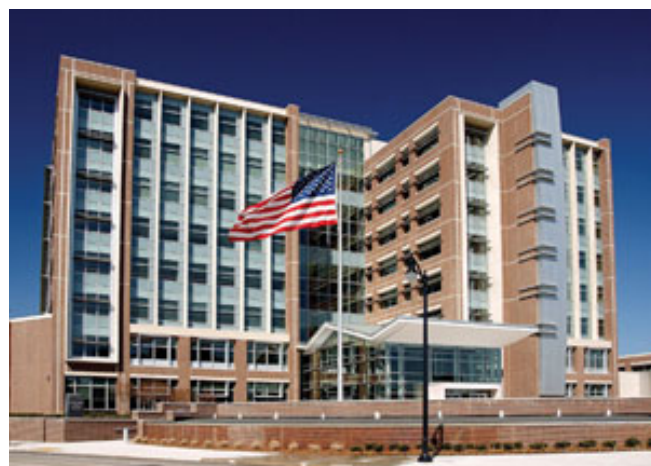
Photo courtesy of Opus South Corp., Atlanta
The completed Birmingham Social Security Administration Center has achieved LEED® Silver Certification.

And the finished roof system has helped the building achieve Silver Certification from the U.S. Green Building Council's Leadership in Energy and Environmental Design® Green Building Rating System.™

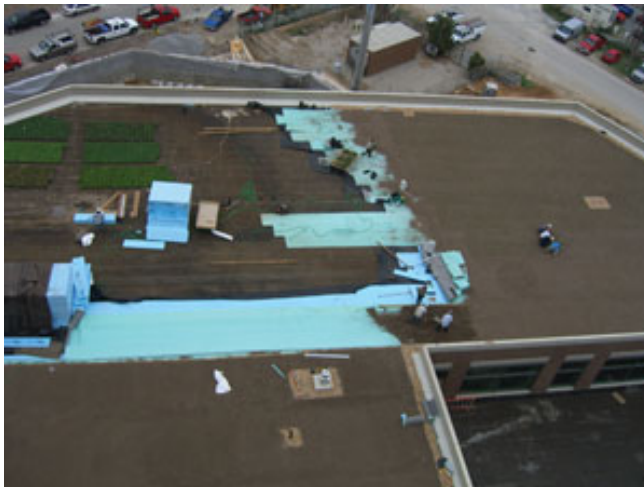
Photo courtesy of Colbond Inc., Enka, N.C.

Before installing the overburden, Construction Services loose-laid a polypropylene composite with a drainage core and a water-retention fabric on one side on the waterproofed deck.

Construction Services resumed work on the roof in late September 2007. Construction Services installed a protection board, root barrier and 3-inch-thick Styrofoam™ Plazamate insulation. The crew then loose-laid Colbond Inc.'s EnkaRetain & Drain, a post-industrial recycled polypropylene composite with a drainage core and a water-

retention fabric on one side, on the waterproofed deck.

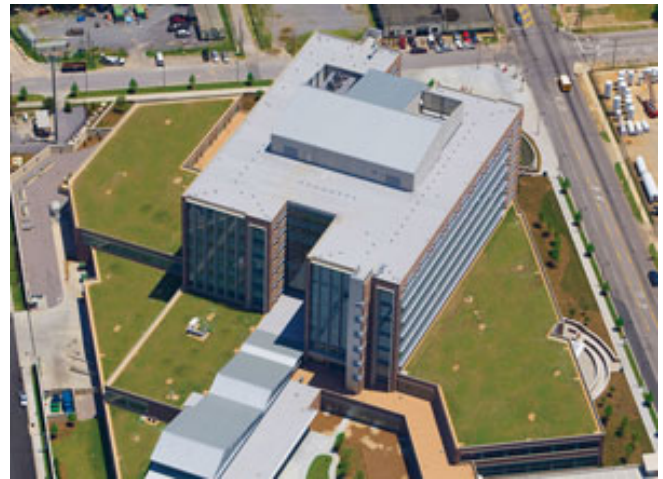
Photo courtesy of Sky-Shots Aerial Photography Inc., Atlanta

More than 1,000 cubic yards of growing medium and more than 160,000 sedum plants were installed on the building's second-floor rooftop.

Next, more than 1,000 cubic yards of growing medium and more than 160,000 sedum plants were hoisted to the roof and installed.
