CURB DETAIL

2.67" X 7/8" CORRUGATED
PANEL

PETERSEN ALUMINUM CORPORATION

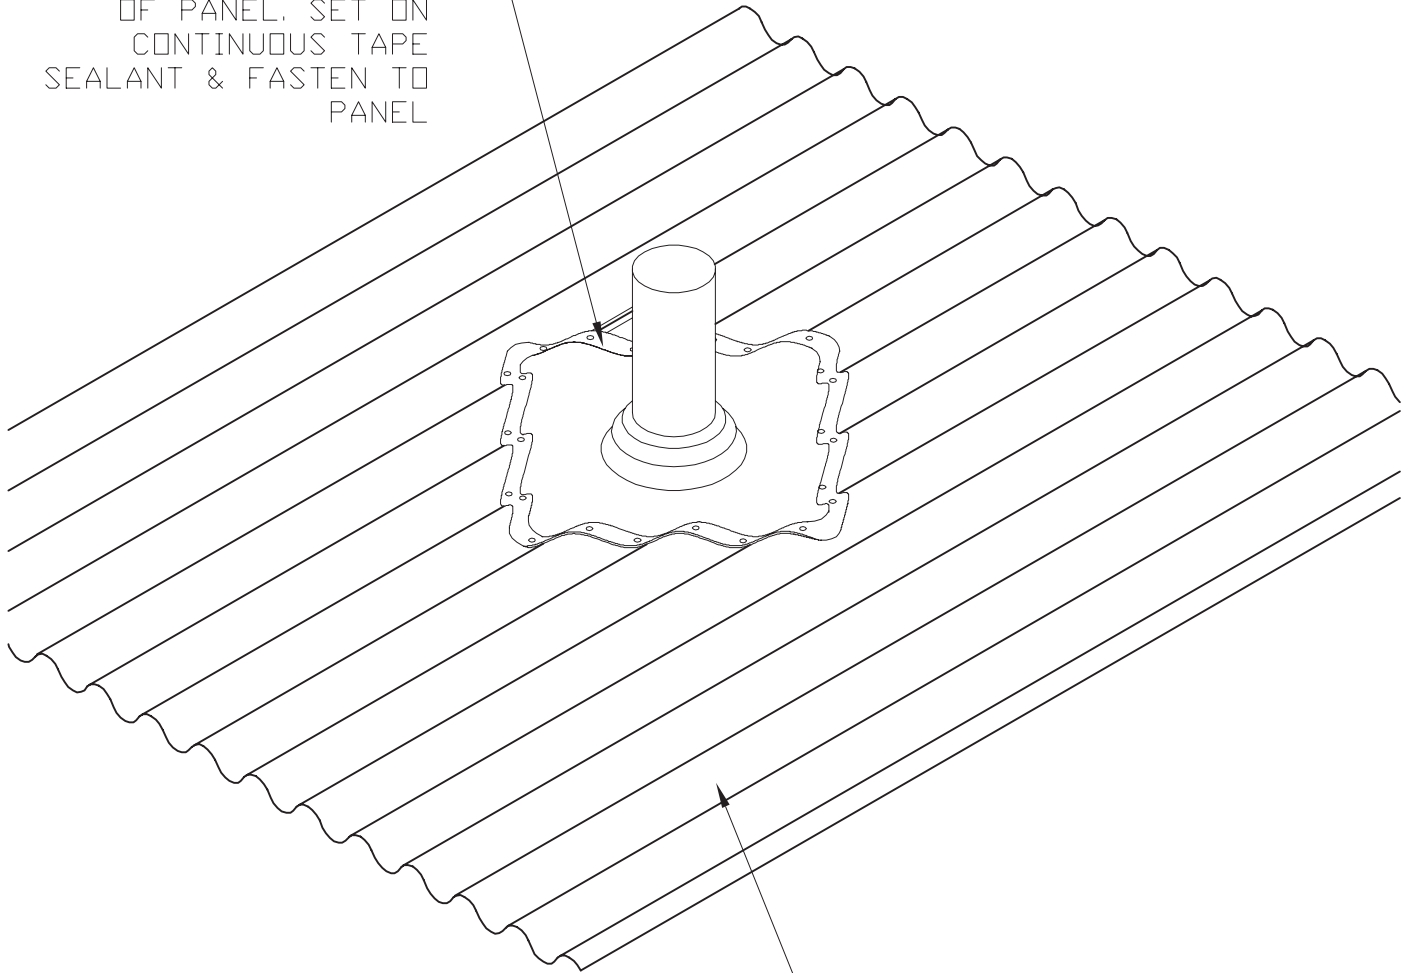
2.67" X 7/8" CORRUGATED

PIPE BOOT W/
STAINLESS STEEL
COLLAR SET IN
DIAMOND FASHION, BEND
TO FORM W/ CONTOUR
OF PANEL. SET ON
CONTINUOUS TAPE
SEALANT & FASTEN TO
PANEL
